Subject: Fw: Bridgeton Landfill Fire Event

Bridgeton Landfill Fire Event

Bridgeton Landfill Fire Event 02162014

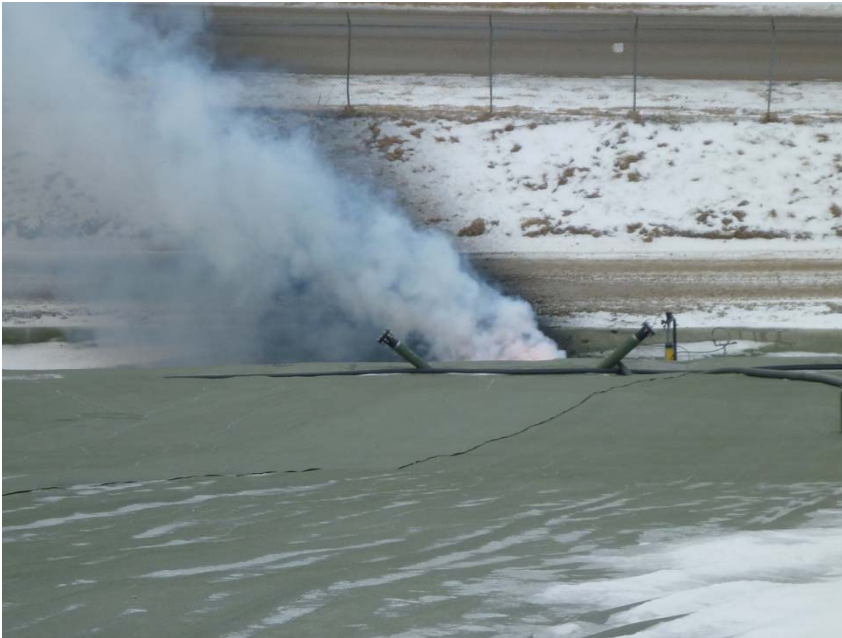
2/16 @ 0935 hrs. Photo taken standing in the SQA, the view is southwest. The fire and steam/smoke cloud is shown. The flames scorched the gravel pathway and grass but did not appear to leave the site perimeter.

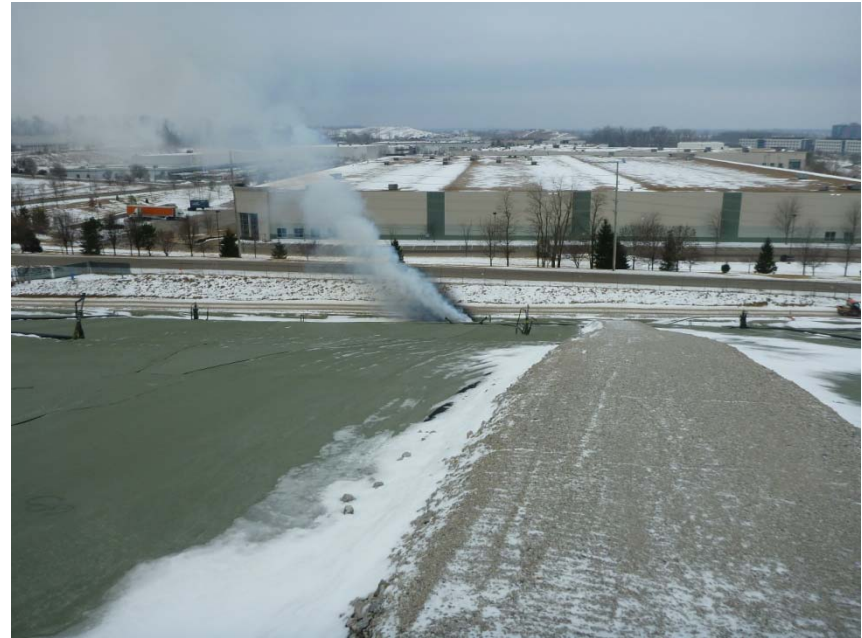
2/16 @ 0935 hrs. Photo taken standing in the SQA, the view is southwest. The fire and steam/smoke cloud is shown. The flames scorched the gravel pathway and grassy area, but did not appear to leave the site perimeter. Boenker Lane can be seen in the background.

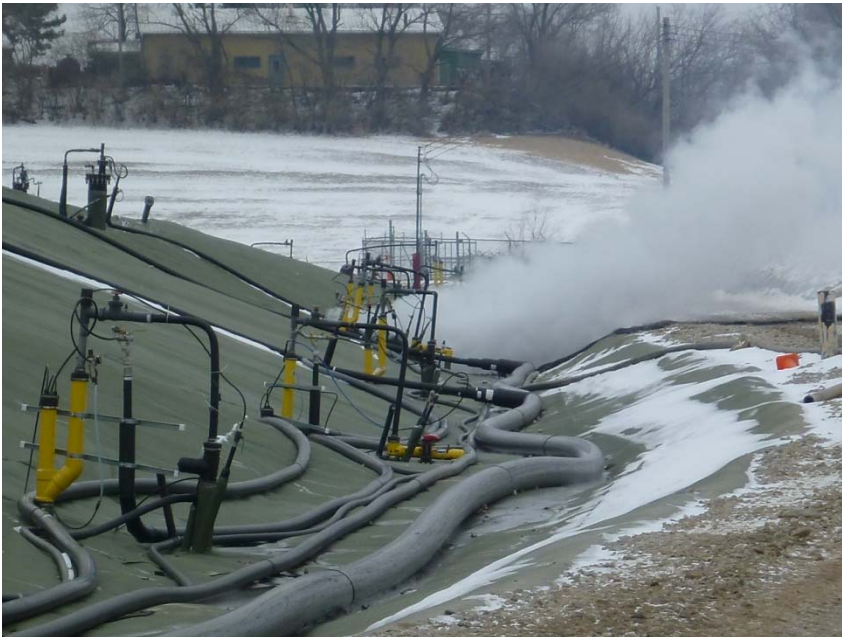
02/16 @ 0959 hrs. Photo taken standing in the SQA, near gate 2, on Boenker Lane, the view is southeast. The fire and steam/smoke cloud is shown. Most of the smoke is due to the compressed air coming thru the liner. The temperature gradient caused most of the misting in the area. Small flames can be seen in/around the piping.

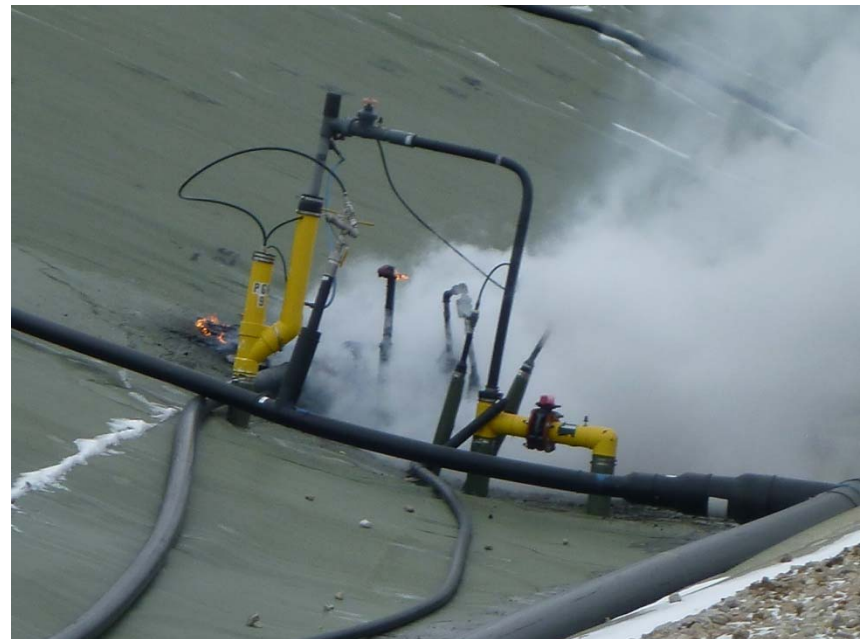
02/16 @ 1002 hrs. Photo taken nearer the air lines and relief valves, the view is east. The fire and steam/smoke cloud is shown. Small flames can be seen in/around the piping.

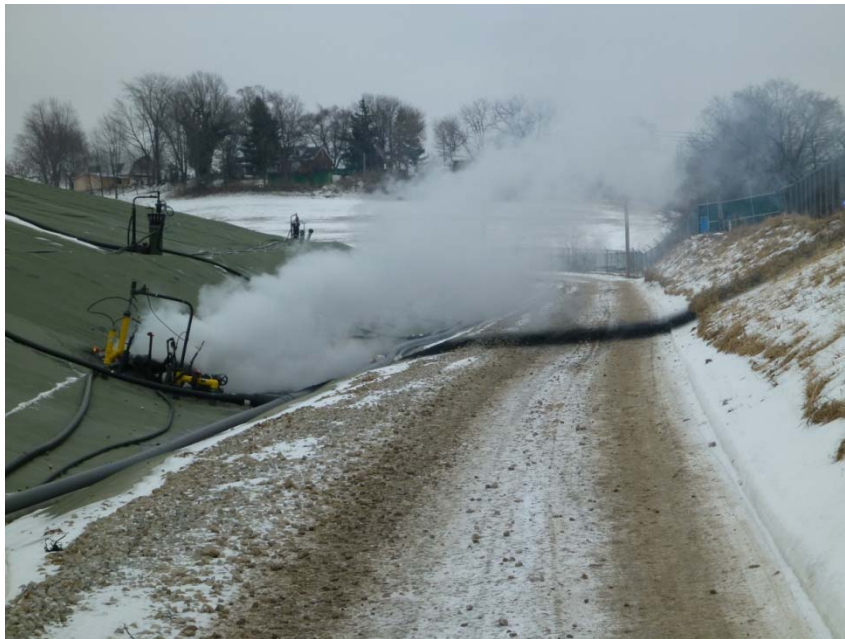
02/16 @ 1002 hrs. Photo taken standing in the SQA, near gate 2, on Boenker Lane, the view is east. The fire and steam/smoke cloud is shown. At the height of the flames, the photo shows where the gravel path and grassy area was scorched.

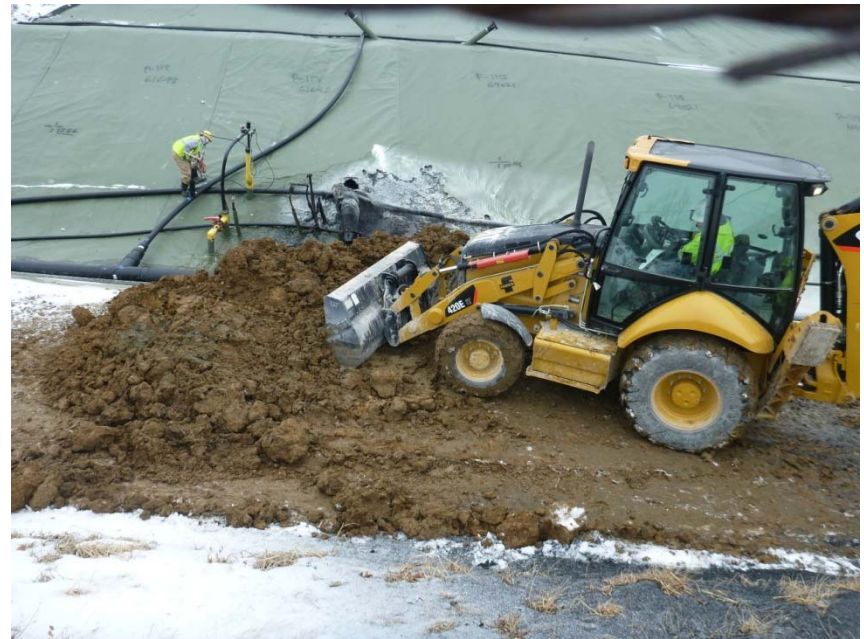
02/16 @ 1104 hrs. Photo taken standing on Boenker Lane, the view is northeast. Republic has responded to the scene and is in process of putting out the fire.

Republic responded promptly to the scene and pinched off the flow of air to this area. They allowed the subsequent gases, no longer under pressure, to burn themselves off. The resultant fire was extinguished around 1030 hours and the area was covered with dirt. Republic is now in the clean up and recovery phase

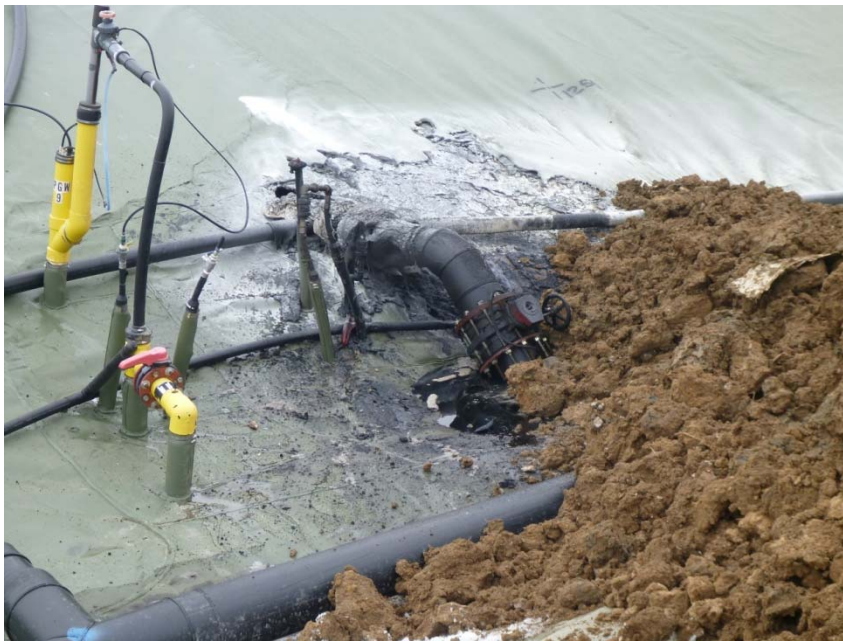
02/16 @ 1104 hrs. Photo taken standing on Boenker Lane, the view is east. Republic has responded to the scene and is in process of putting out the fire. The liner breach can be seen.

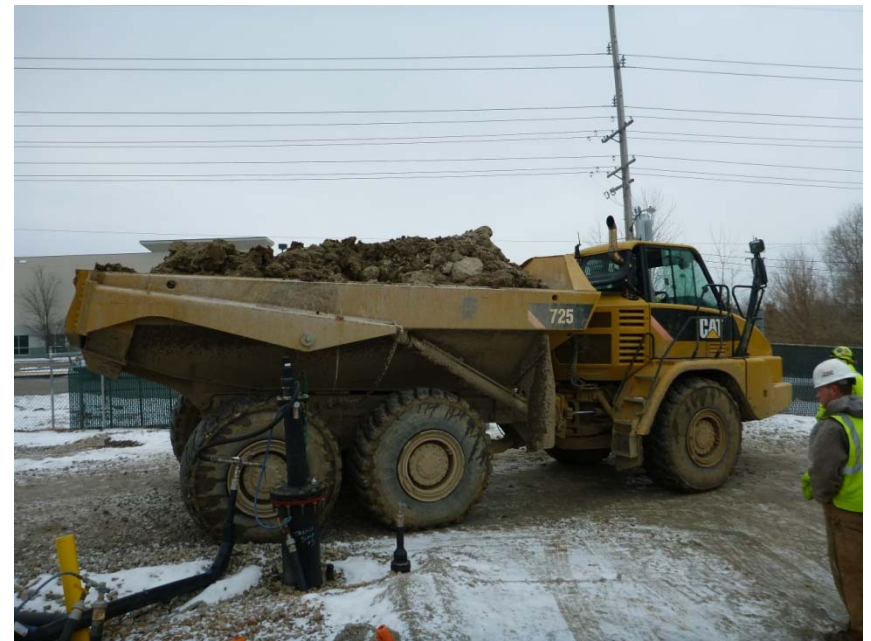
02/16 @ 1107 hrs. Photo taken standing in the SQA, near gate 2, on Boenker Lane, the view is southwest. Republic is using dump trucks to haul dirt to the scene to put out the fire. They were in the clean up and recovery phase.
